TT 185E
Issue 3/2008

AVIATION SAFETY LETTER

Understanding Altitude Deviations

Heads Up! Aeroplane Design and Operations in Icing Conditions

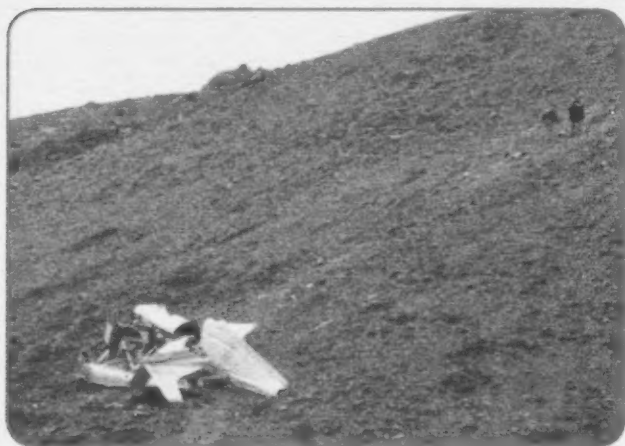
Aerial view of accident site, with TSB investigators at the approximate impact point

1. While flying in mountainous terrain, the pilot was manoeuvring close to terrain, and struck the ground at slow speed, with the aircraft in a nose-down attitude, possibly after a stall.
2. The pilot's lack of experience in mountain flying likely caused him to misjudge how close to the terrain he could safely fly. The strong wind from the southeast may have been a factor.

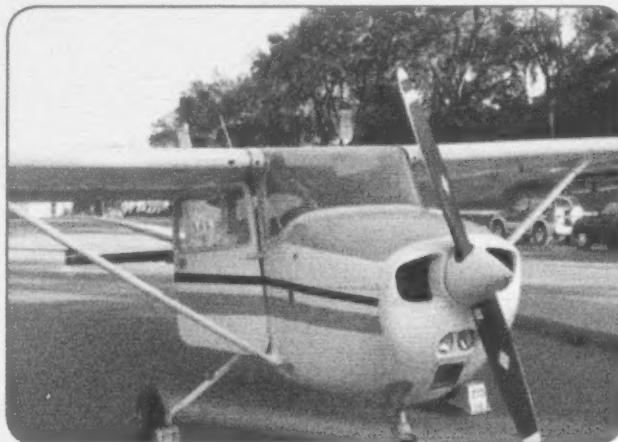
The pilot tried to restart it, but without success. The pilot transmitted a distress message and quickly reported the situation to the control tower. The aircraft was approximately 1 250 ft above ground level (AGL) at the time. The pilot landed the aircraft on the northbound side of Parc Avenue, in Montréal. On landing, the left wing tip struck a traffic light post before the aircraft came to rest. The aircraft was substantially damaged, but there were no injuries.

1. The aircraft was not on level ground when the draining was done before the flight. Consequently, the water in the fuel tank was lower than the drain valve and could not be removed with the pipette.
2. The water accumulated in the right fuel tank migrated to the gascolator bowl, saturating it, and causing the engine to stop.

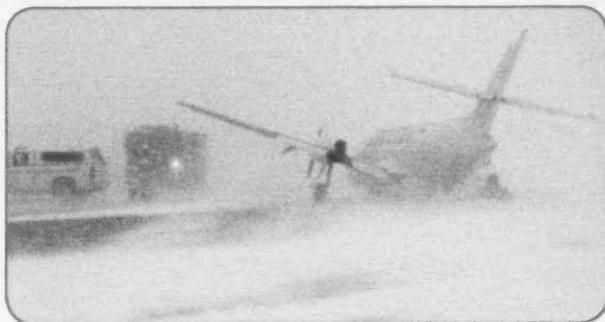
This picture taken shortly after the occurrence illustrates the poor visibility

On January 9, 2007, a British Aerospace Jetstream 3112 was conducting an instrument approach to Runway 29 at Fort St. John, B.C., on a scheduled instrument flight rules (IFR) flight from Grande Prairie, Alta. At 11:33 Mountain Standard Time (MST), the aircraft touched down 320 ft short of the runway, striking approach and runway threshold lights. The right main and nose landing gear collapsed, and the aircraft came to rest on the right side of the runway, 380 ft from the threshold. There were no injuries to the two pilots or 10 passengers. At the time of the occurrence, the runway visual range (RVR) was fluctuating between 1 800 ft and 2 800 ft in snow and blowing snow, with winds gusting to 40 kt.
